Commercial Building Survey of Retail

Property: **Case Study**

Property: Three storey property constructed in the late 19th century. Originally mid-terrace, but one side was demolished following substantial war damage.

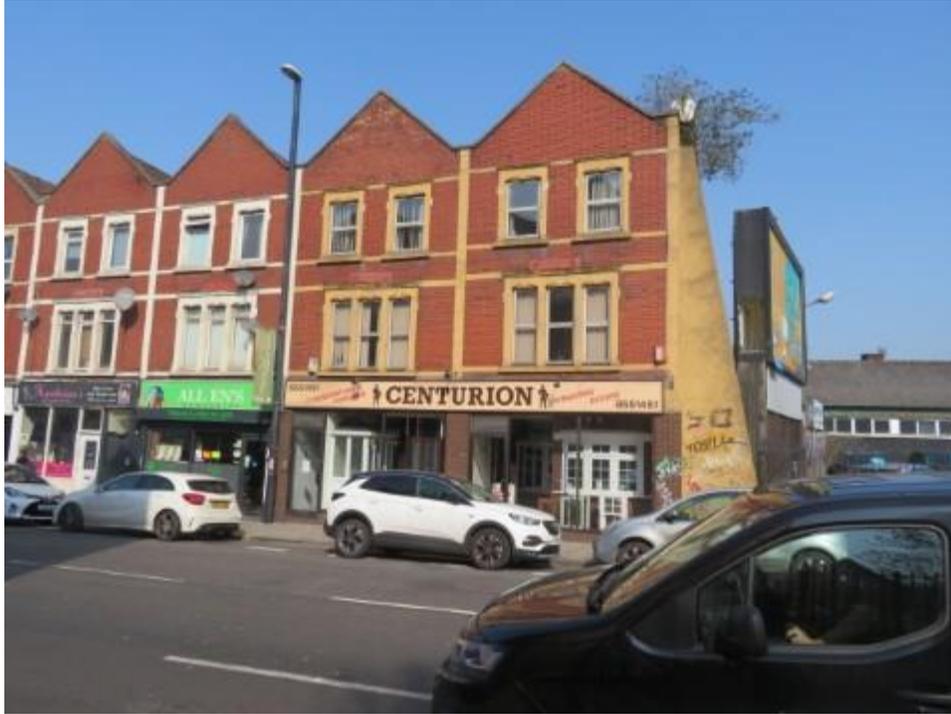
- The building was a mid-terraced three storey property believed to have originally been constructed circa 1880, with later single storey extensions to the rear.

- The remainder of the terrace has been demolished due to substantial damage occurring during the war.
- Internally, the property consisted of a commercial retail unit and several offices.

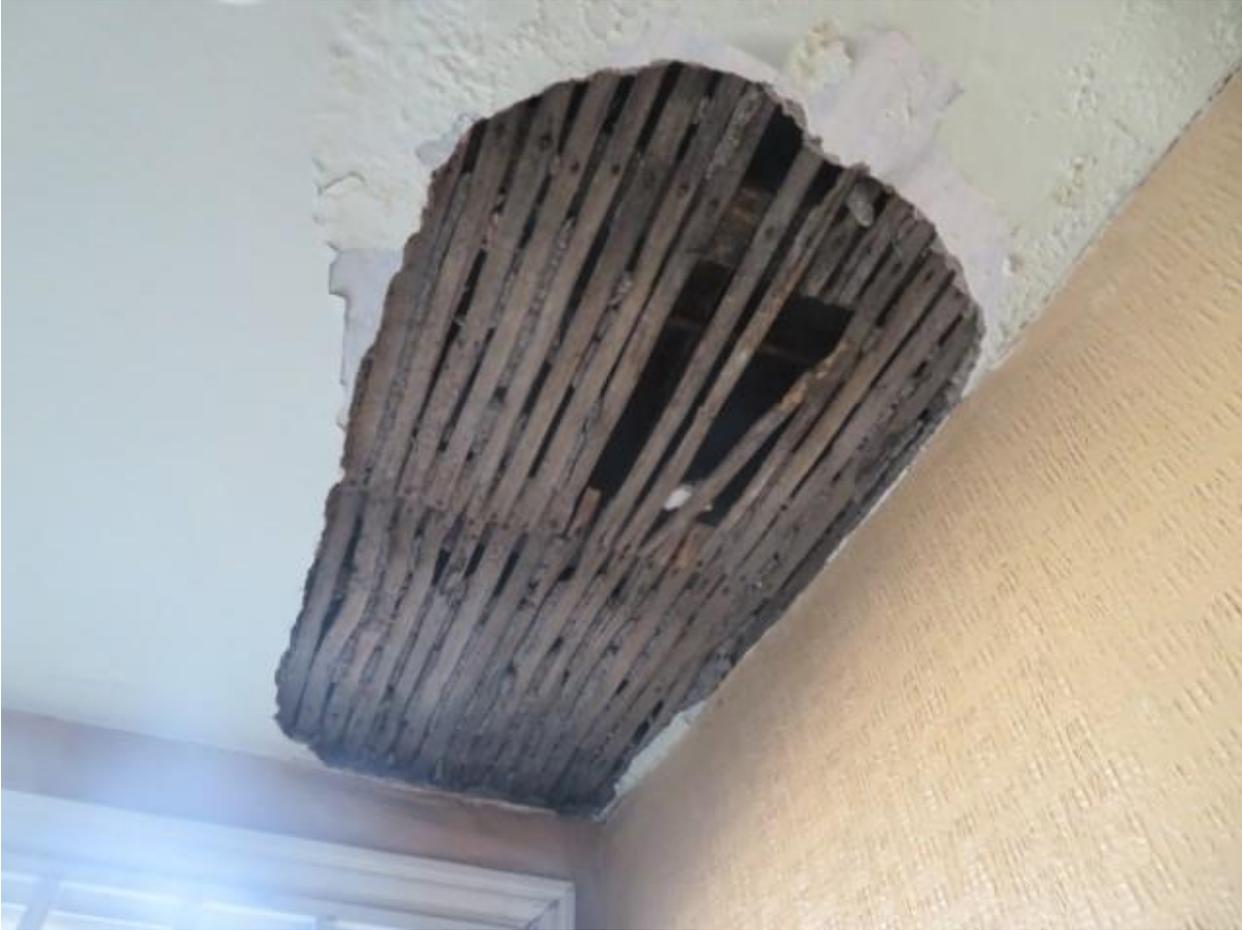
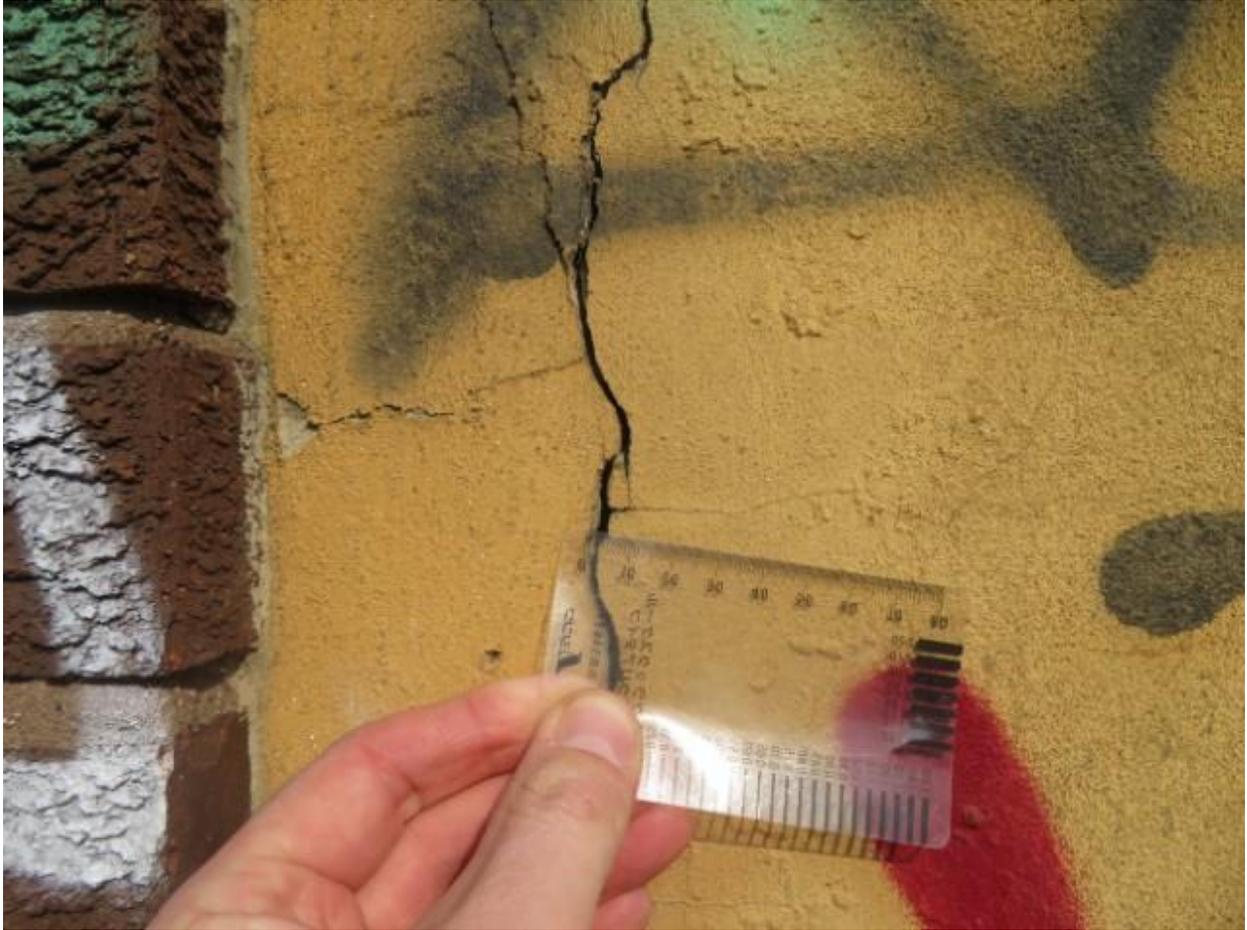
- Structurally, much of the movement and distortion seen in the property appeared to be a result of the demolition of the adjoining terrace.
- However, although some steps had been taken to address the movement, these were found to be insufficient.

- We also cautioned that the parapet brickwork needed to be investigated further – to do this, loose render and vegetation would need to be removed. We believed that the brickwork was likely to be unstable, and advised our client to budget for reconstruction.

- Our structural engineer recommended installing Helifix stainless steel Helical bars or similar between the front elevation and the internal floor joists at first and second floor, to provide restraint to the elevations. We also recommended installing ties to reconnect the front and rear elevations to the party wall.
