Schedule of Condition of Industrial Units in Runcorn: Case Study

Property: Two adjacent commercial industrial units, approx. 6800 sq.ft in total.

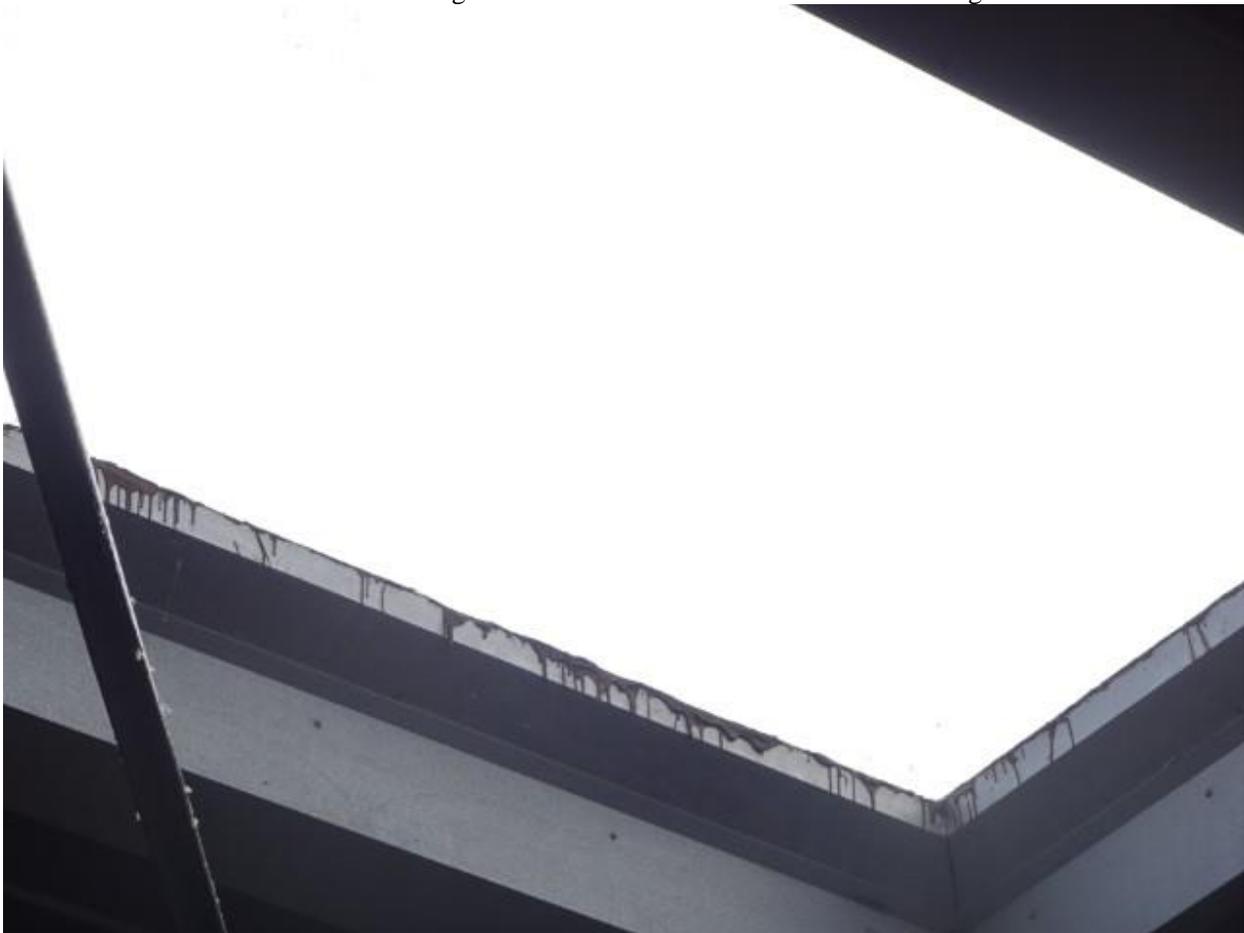
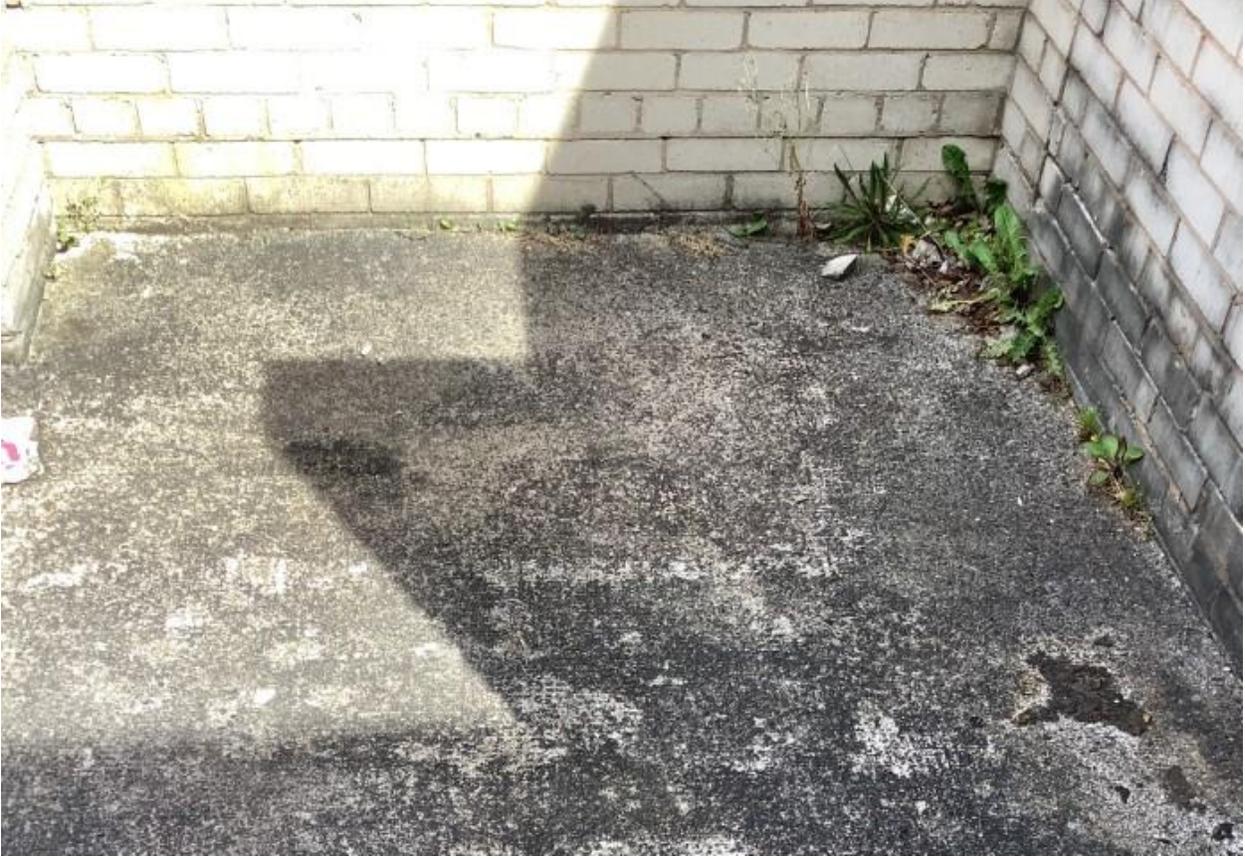
- Our 360-page report included over 550 photos detailing the condition of the industrial units.
- Observations on the external condition of the property included:
 - the felt roof covering was in a poor state of condition, with water pooling in several areas
 - previous localised repairs to the roof
 - soiling and vegetation growth to the hard standings
 - surface staining to window frames
 - previous masonry repairs
 - blemishes and deterioration to the metal gate posts.
- Internal observations included:
 - liquid applied coating had been used around rooflights, suggesting historic or live water ingress
 - evidence of damp on lower levels of the main walls
 - debonded seals around an escape door
 - surface cracks and water blemishes on some ceilings
 - minor blemishes and signs of wear were noted and documented throughout.
