# Care Home In The South Of England

Contour has successfully surveyed, supplied, manufactured, and installed 47 LST radiator covers and 100 m worth of pipe boxing for a care home in the South of England.

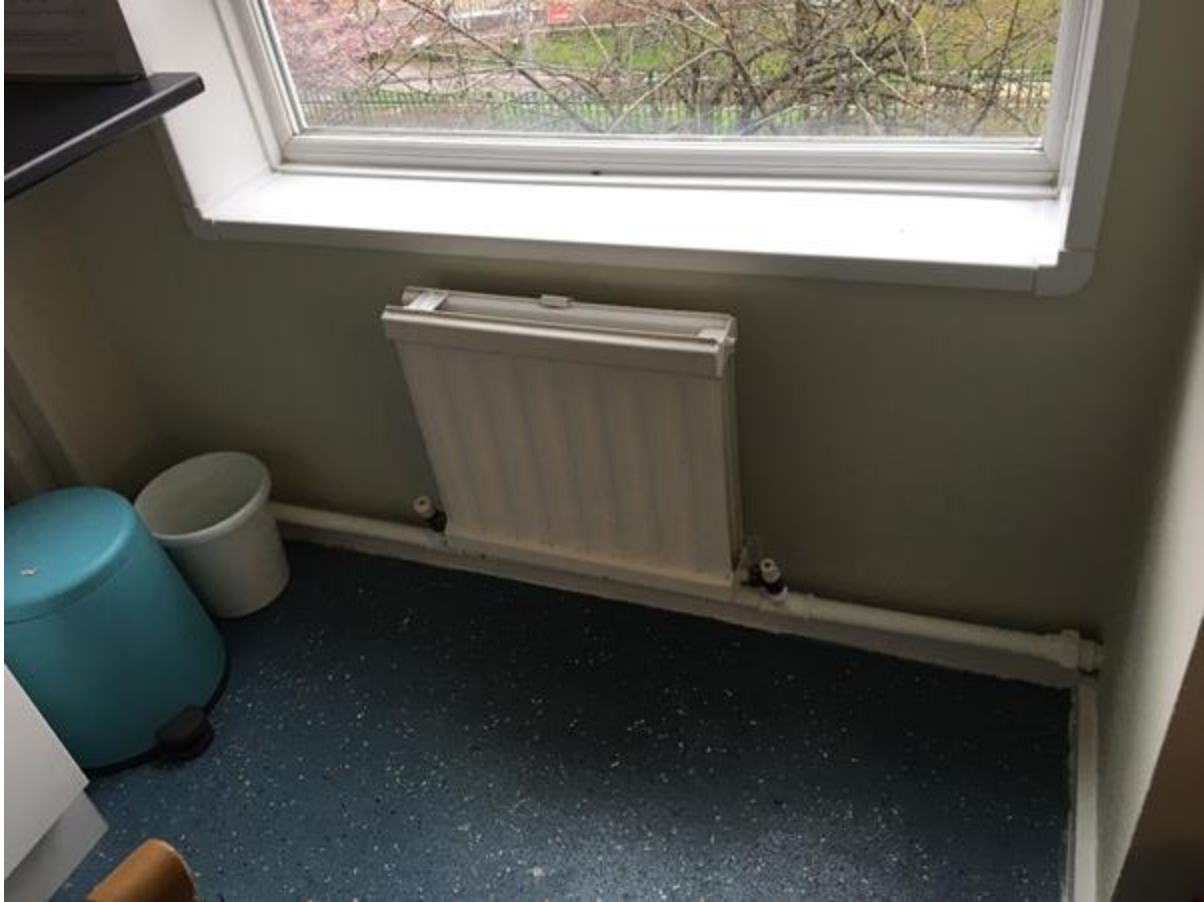
## Exposed Piping

Prior radiators at this care home had **exposed piping**, this can reach up to a staggering 80°C. This provides potential dangers to the vulnerable individuals at the care home and doesn't align with safe surface heating guidelines.

An individual could have seriously scalded themselves on the high heat temperature of the piping.

Pipe boxing was fitted to hide the exposed pipework. Contour's pipe boxing is fully encapsulated in a 8mm thick preformed plywood making it highly effective at avoiding burns and scalds, encapsulating the pipework in an attractive casing that blended into the existing décor.

The care homes pipe boxing meant that service users were now protected from scalding themselves on exposed piping.

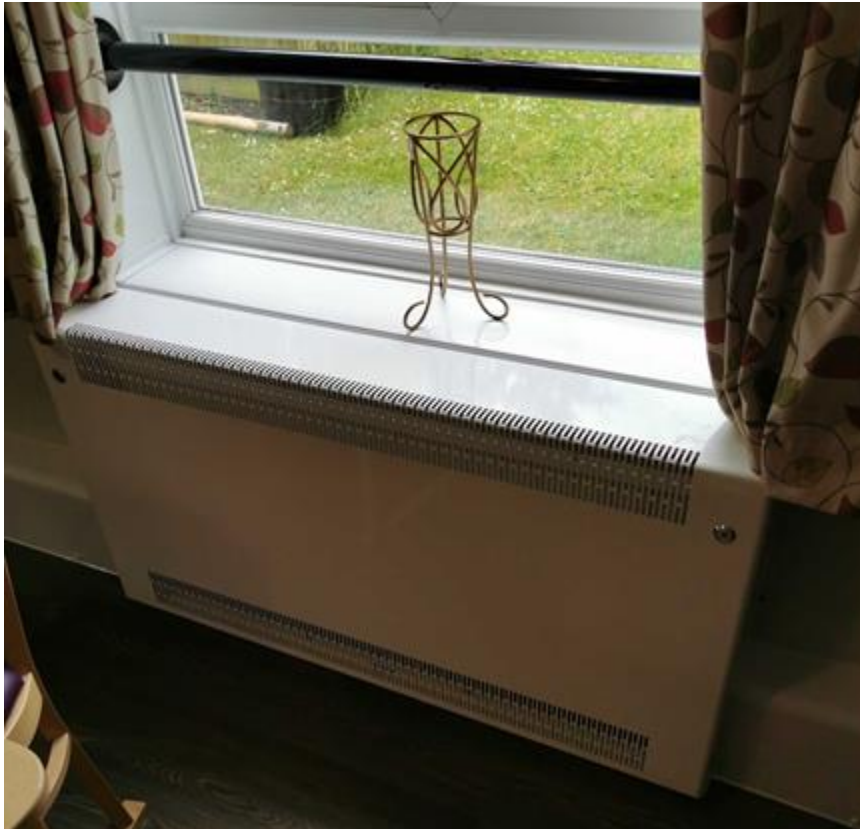
A retro design was installed with a bespoke solution with Contour's **Deepclean** radiator covers.

The DeepClean LST radiator guard is built using a patented, quick-release hinged door. This allows the front of the casing to be laid flat on the floor to provide easy access to clean the radiator.

These features allow for cleaning and maintenance to be optimised, something the care home was not able to do with previous radiators.

As standard, most of Contour's LST Radiators come with **BioCote®** protection. This unique powder coating can help combat a range of dangerous bacteria such as MRSA and E.coli, reducing the spread of infection in the care home.

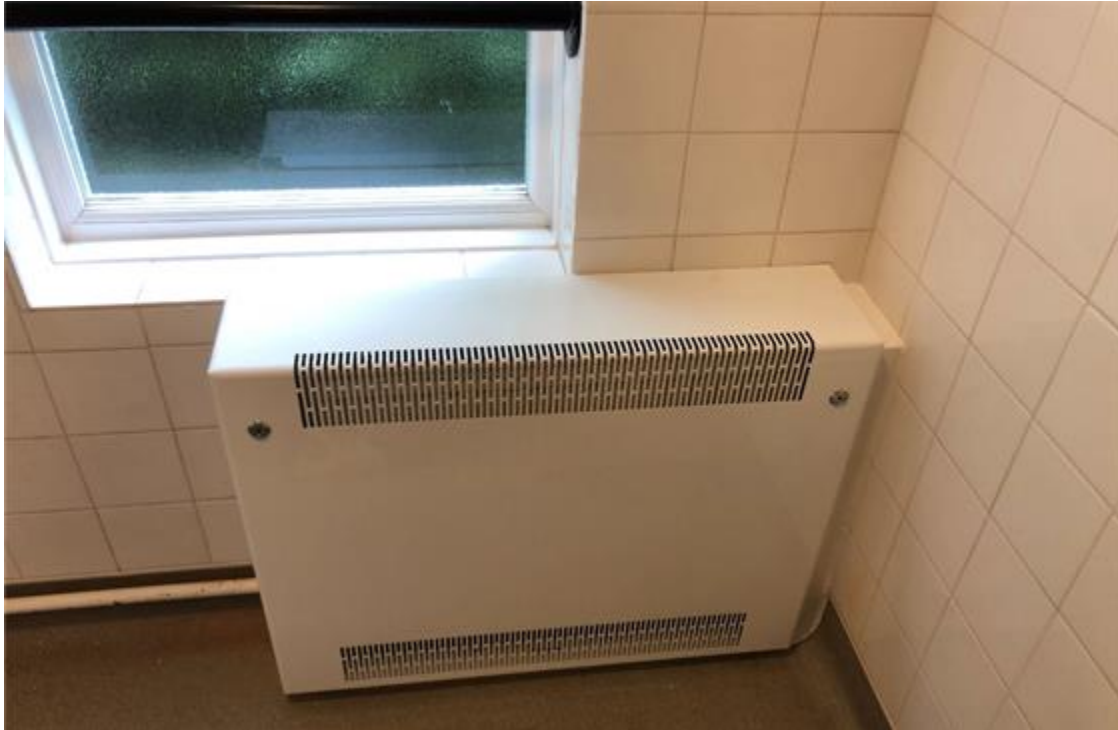
## Open-Ended Shoulders (OES)

To reduce **dust traps**, the Deepclean LST radiators were installed with open-ended shoulders. This meant that the radiators were sealed to ensure dust traps were minimised to protect service users from dust-related issues.
