# Case Study: Grosvenor Shopping Centre

**Project:**  
Grosvenor Shopping Centre

**Location:** Northampton

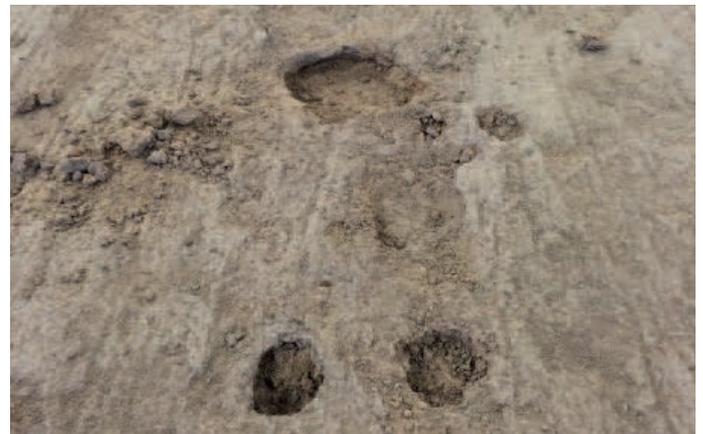
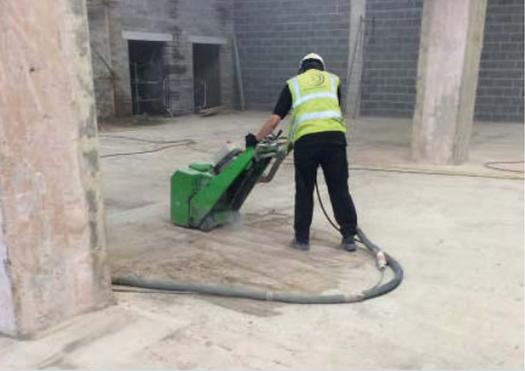
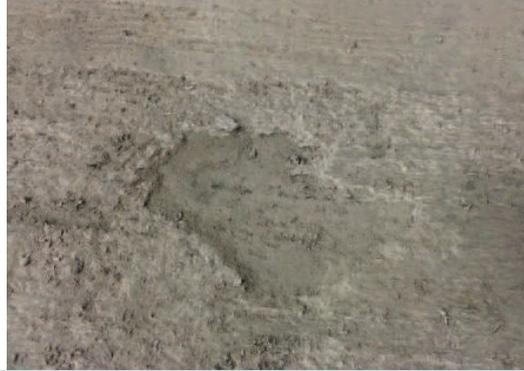
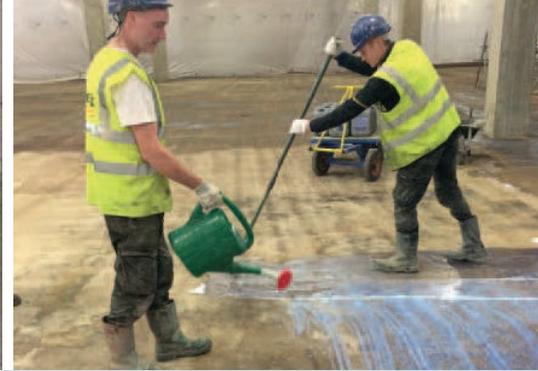
Prior to shop fit-out, the project required Zenith Pola Flooring to provide a flooring system for both shops, successfully overcoming problems of water ingress and weak substrate within a tight time-frame. The existing screed was found to be in a poor state, with old adhesive residues, latex and loose material covering

the entire area and numerous wet sections that could not be dried in time, due to water ingress.

Primark's specification required a SR1 tolerance of +/- 3mm over a 2m straight edge, with a finished floor level no greater than 15 mm above datum. Next's specification required a higher tolerance of +/- 3 mm over a 3 m straight edge. Due to differences in level and channels in the floor, it also required a higher level of preparation to bring the floor to the necessary standard before the floor could be installed.

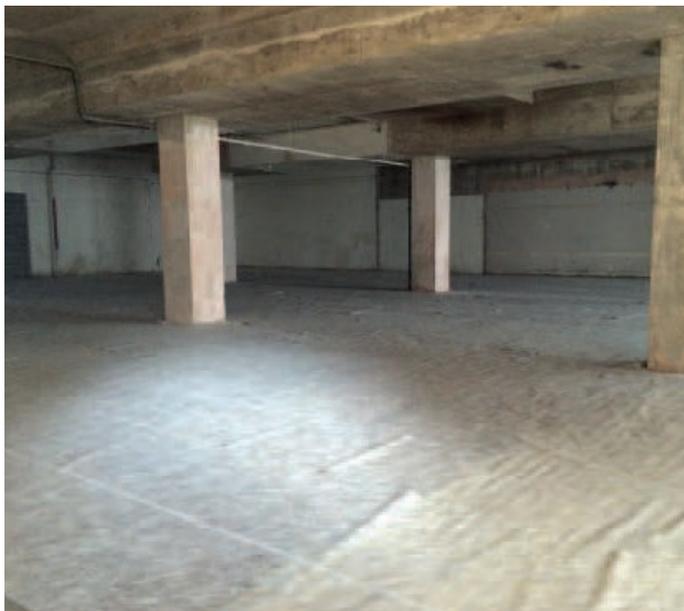
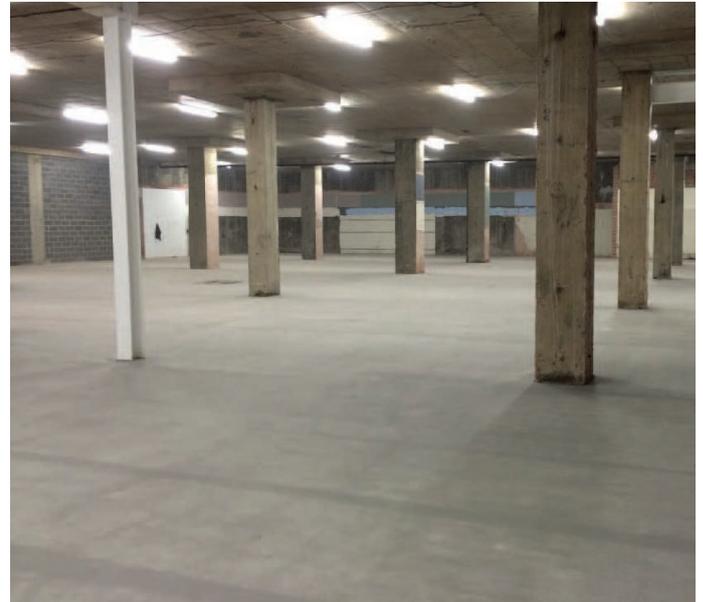
To reduce levels in order to comply with datum tolerances, it was first necessary to plane approximately 1300 m<sup>2</sup> to allow the minimum thickness of product to be applied. To plane the entire area down to 50-60 mm and get back to sound concrete or screed would have been time-consuming and economically unviable, calling for an alternative, specialist flooring installation. Therefore, a quick STR grind was carried out to remove any loose surface materials and UZIN's PE 425 case hardener was applied, penetrating the surface of the existing screed and reinforcing the weak and unstable substrate. UZIN PE 480 DPM was applied to the ground floor, and areas that could not be dried in time were treated with UZIN PE 414 Turbo, a rapid drying DPM.

UZIN PE 280 was applied next to the ground floor and UZIN PE 360 to the entire first floor, both rapid drying primers that cure within 45 minutes. UZIN RR 201 fibreglass mesh was then rolled out and FM 30 Industrial Top pumped in, causing the mesh to disperse. This formed a matrix in the screed, increasing its compressive and tensile strength to provide a failsafe solution, which overcame the site's inherent problems, within the given time parameters.
